Details of a Survey of the Stone Stiles of Cam in March 2007

By Matt & Shirley Welsh, Ray Sherman and John Fowles

This survey was carried out in the winter months, March 07, when the vegetation was light. It is intended that the results be used to assess the condition of the stiles and to identify where maintenance is necessary and beneficial.

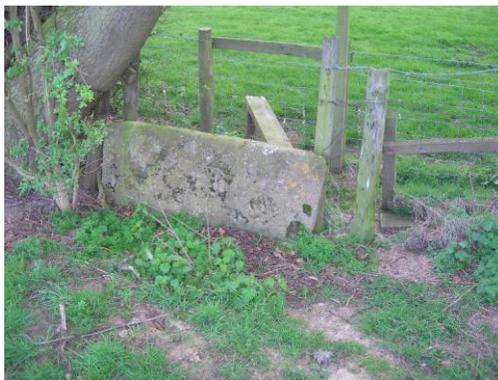
SS1 is on CCA63 and is in good condition. It is leaning slightly but is partially supported by the posts of the adjacent wooden stile. It could be raised to the vertical but it is probably not worth the effort.

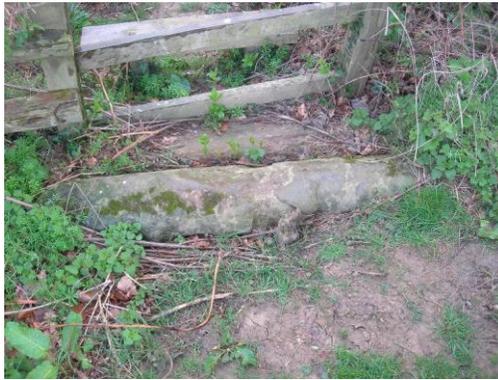
SS1A is on CCA60 and is very low. It is probably a complete stile leaning forward from the wooden stile and sunk deep into the ground. It is worn where walkers step onto it after crossing the wooden stile. With considerable effort it could be excavated and raised to the vertical but the wooden stile would need to be rebuilt.

1. Create labelled marker posts for each remaining stone stile to ensure that they are recognised as historical artefacts and don't get destroyed like SS7.
2. SS1A should be raised and set upright with a wooden framework to help support it and protect it from further damage.
3. SS3 should be raised to the vertical against the existing wooden fence.
4. SS4 should be raised and set upright with a wooden framework to help support it and protect it from further damage. The broken section could be incorporated.
5. The broken half of SS6 should be reset in its original position and the completed stile supported/protected by a wooden frame.

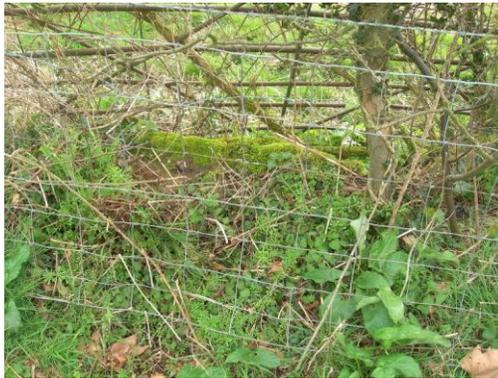
SS1B is on CCA64 by the wooden stile immediately to the west of SS1A. It is deep within the hedge and covered in moss and grass making it difficult to spot. The removal of the grass and other plants to make it more visible would be beneficial.

It is recommended that permission is sought from landowners to cut back vegetation, where necessary, to make the stone stiles more visible. A plan should then be created to carry out the following work if sanctioned by the County Archaeologist:

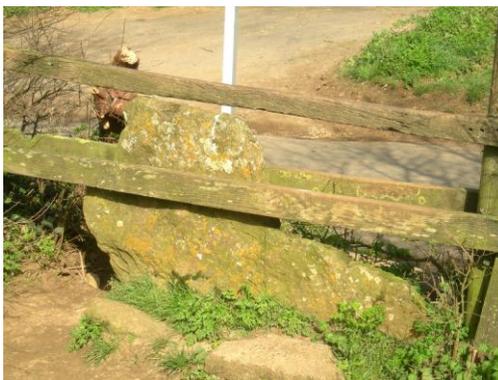
Stone Stile 2

SS2 is a single stile to the west of Field Lane at the start of paths CCA13 and CCA14 - map reference 738004 (near to the mobile phone mast). The stone is broken but the larger section is upright and supported and protected by the wooden stile. No work is required on this stile.

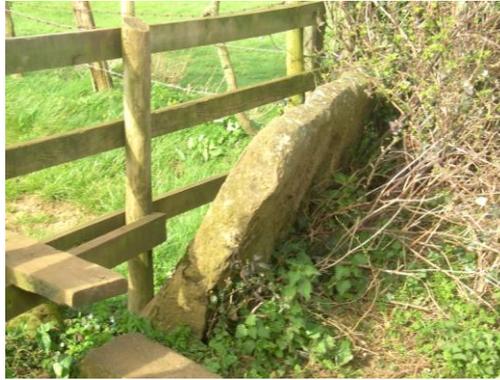
Stone Stile 3

SS3 is a single stile beyond an excavated area on CCA13, the same path as SS2. It is at map reference 734004. It is leaning slightly away from the wooden stile and is supported by a small earth bank covered in vegetation which grows across the stone in summer. The stone could be raised to the vertical and supported on the earth bank side by a protective wooden frame. The dense vegetation could be removed from the earth bank making it more visible.

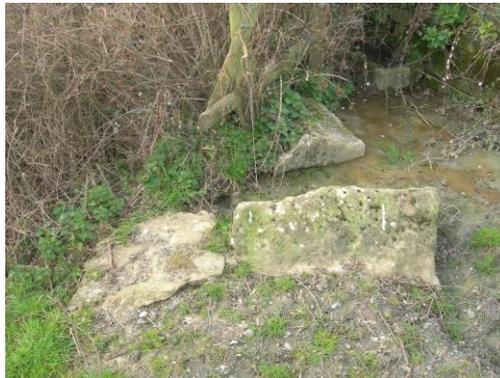
Stone Stile 3A

This is not necessarily a stone stile but we felt that it probably was. It is at map reference 734003 next to a spring that feeds a trough and a few metres down hill from a wooden stile. It is in the same boundary hedge as SS3 but about a hundred metres to the south adjacent to a different footpath, CCA10. It is close to horizontal and broken and would require considerable effort to raise it in a suitable position.

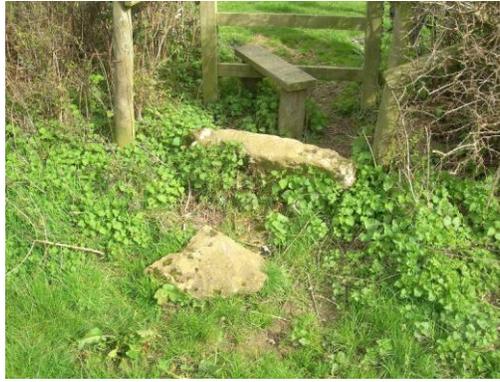
Stone Stile 4

SS4 is a single stile on CCA13 at map reference 733004. It is leaning away from the wooden stile and appears to have a piece broken off and lying nearby. The stone could be raised to vertical, incorporating the broken bit if appropriate, and incorporated into the wooden stile. This would require considerable effort and the rebuilding of the wooden stile.

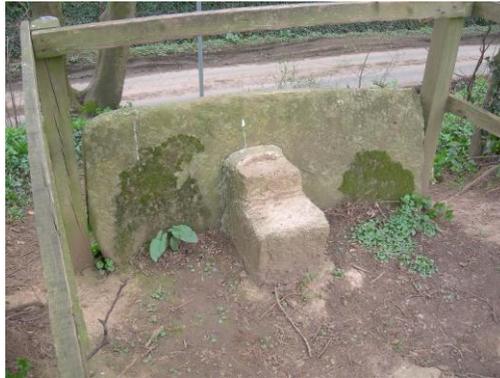
Stone Stile 5

SS5 is at the top of a bank on the east side of Field Lane on CCA20 at map reference 737007. It is upright, incorporated into a wooden stile and supported on each side by concrete steps. No work is required on this stile.

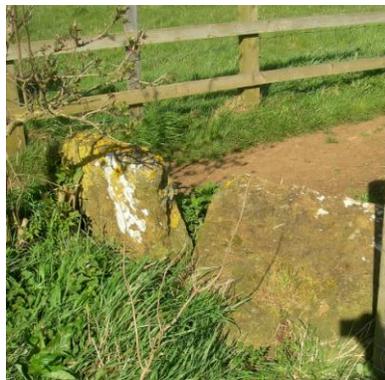
Stone Stile 6

SS6 is on CCA40, approximately at map reference 740004. It is broken in two with one half close to horizontal and the other half close to vertical. It has no supporting frame. It could be put together in a vertical position and covered by a wooden stile.

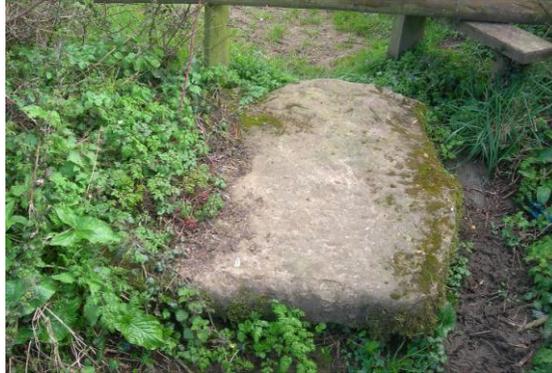
Stone Stile 8

SS8 is near to the Jubilee Field at Draycott on CCA22 at map reference 745010. It lies horizontal next to a wooden stile and appears to be complete although it isn't obvious which edge it originally stood on. With considerable effort it could be raised and incorporated into the wooden stile.

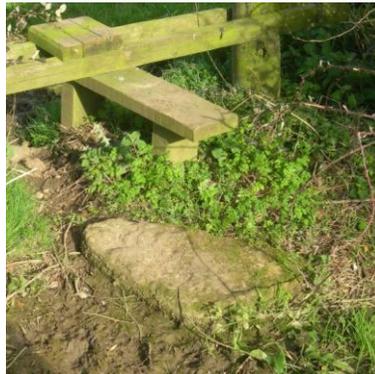
Stone Stile 9

SS9 is a fragment of what could have been a stone stile lying next to a wooden stile on CCA24 at map reference 744015. It is not obvious how it relates to an original stone stile. It could be secured within the existing wooden stile to protect it.

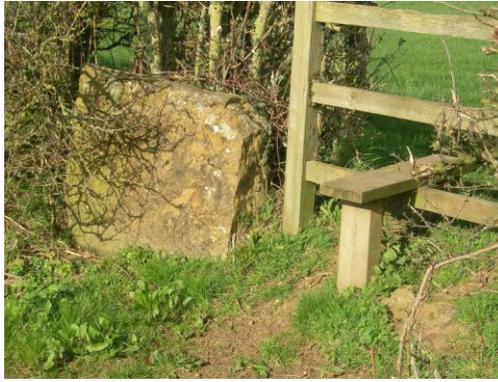
Stone Stile 10

SS10 is close to SS9 on CCA24 at map reference 745015. It stands in the hedgerow next to a wooden stile and is close to vertical. The hedge could be cut back on one side to make it more visible.

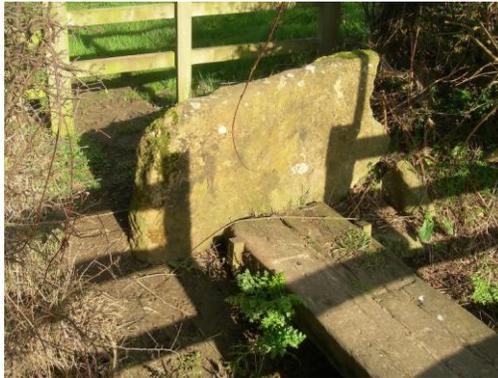
Stone Stile 11

SS11 is in the same footpath as SS9 and SS10, CCA24, at map reference 746016. It stands vertically in between two wooden stiles and requires no work doing to it.

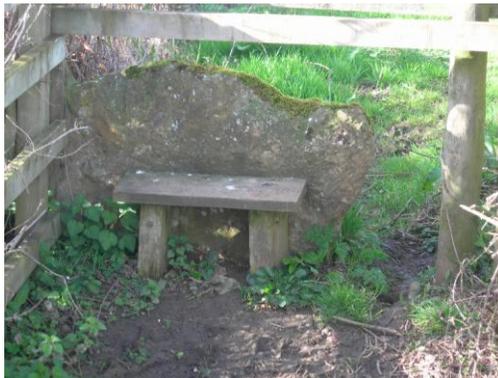
Stone Stile 12

SS12 is just around the corner from SS11, but on CCA25, and at the same map reference 746016. It looks damaged but is vertical and well supported in a wooden stile. No work is required on it.

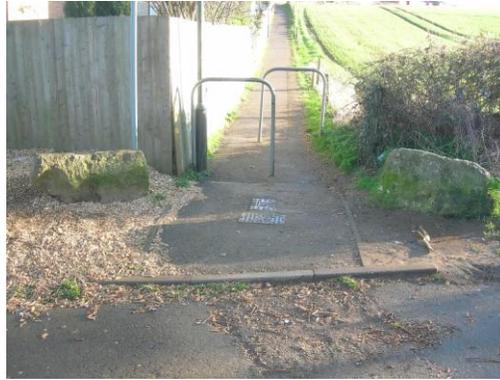
Stone Stile 13

SS13 is the junction of Blind Lane, Elstub Lane and a footpath to Woodfield, CCA50. It is on the edge of the Bovis Estate at map reference 745002. The stone is in two halves and they have been positioned on either side of the start of the footpath to Woodfield. Given that the footpath has been converted to a 'snicket' or urban alley it is not clear how the stile could be replaced. It is probably best left where it is.

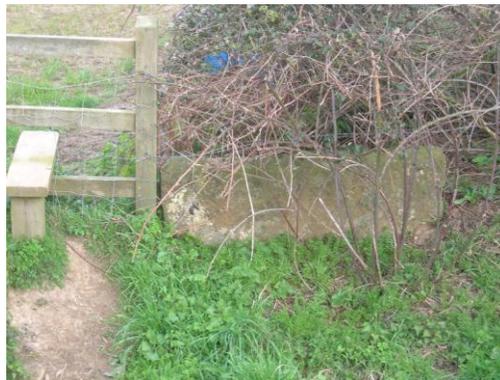
Stone Stile 14

SS14 is on the path between SS4 and SS5, CCA12. It stands next to a wooden stile at map reference 735005. It is close to vertical but is covered by brambles. The brambles could be cut back to make it more visible in summer.

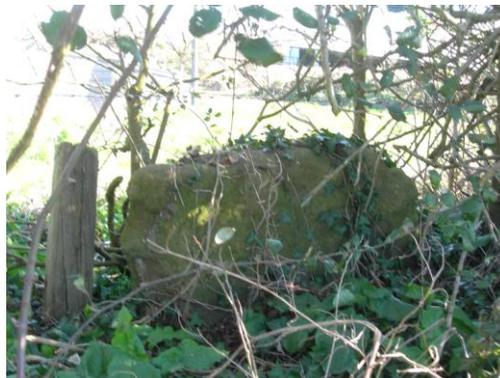
Stone Stile 15

This is a recently discovered stile in Woodend Lane. It is not on an existing footpath but is fairly close to the start of CCA19 and CCA27 and is probably the original starting point of

CCA19. It is at map reference 744007. It is hidden deep in the hedge but appears to be in good condition.
